Environmental Assessment of the Areas Disengaged by Israel in the Gaza Strip

United Nations Environment Programme

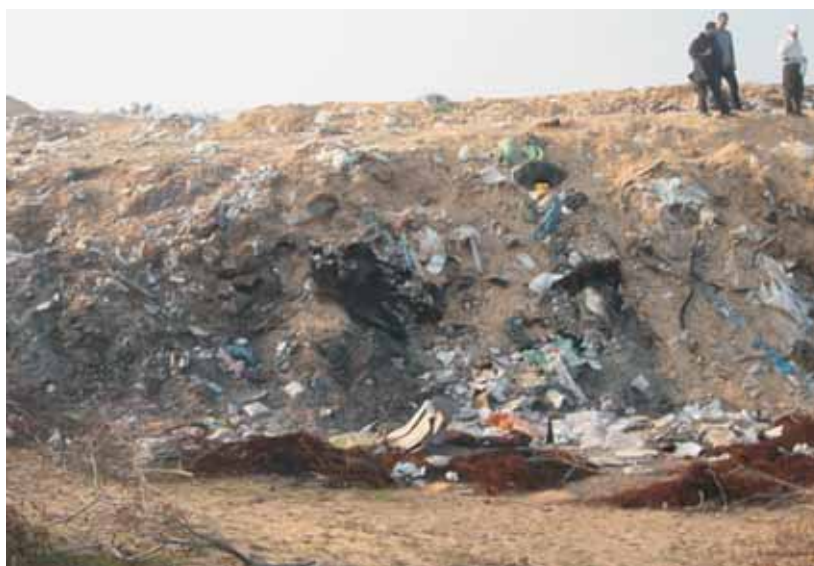
The exposed operational face of the waste disposal site at Kerem Atsama

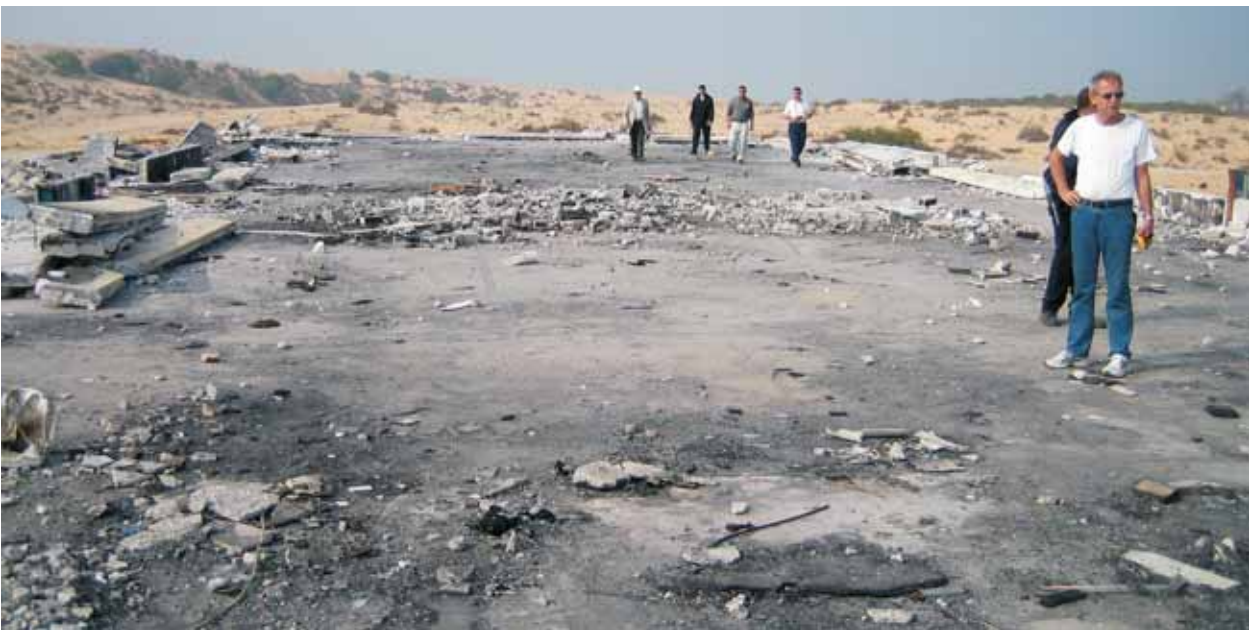
The concrete slab on location A in Rafiah Yam

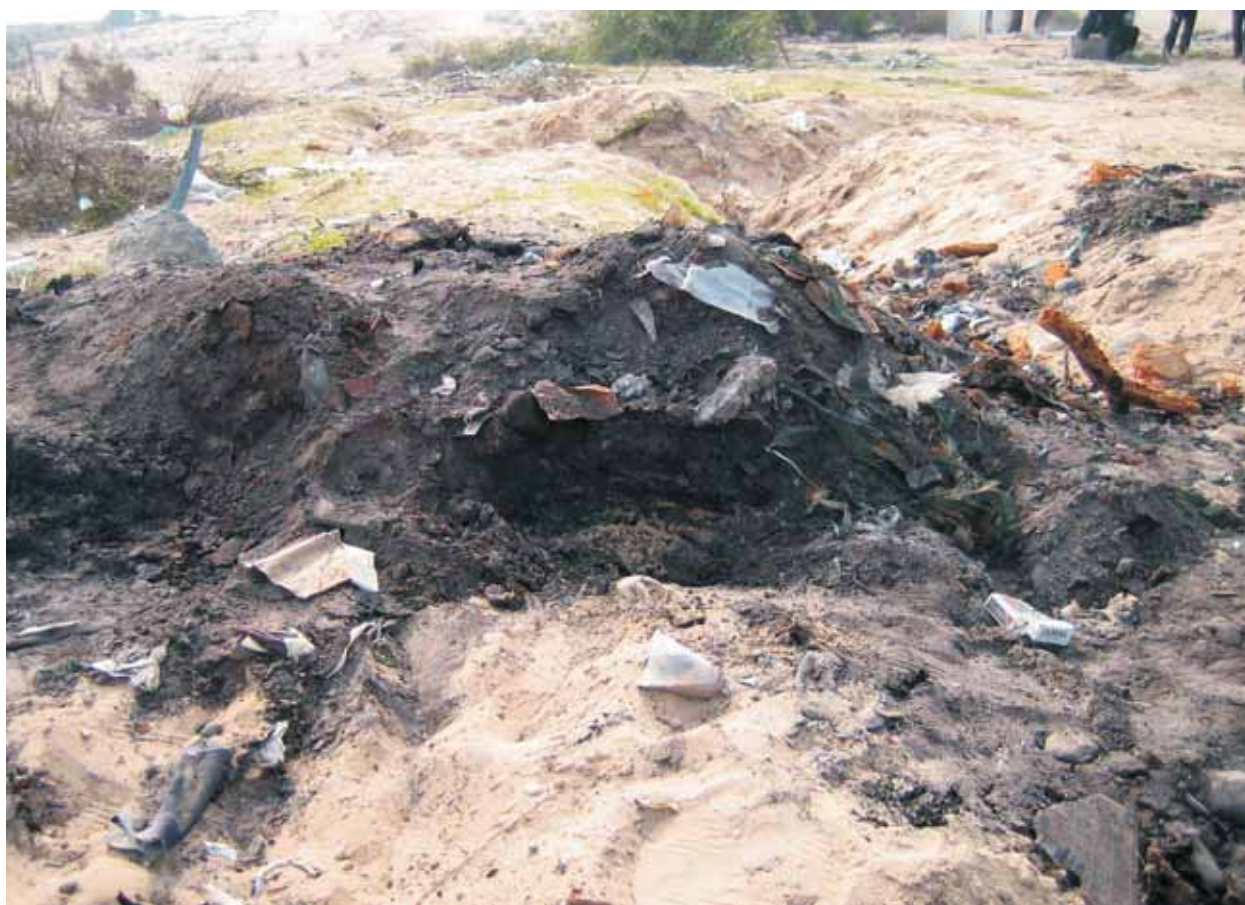
A mound of burned material at location B in Rafiah Yam

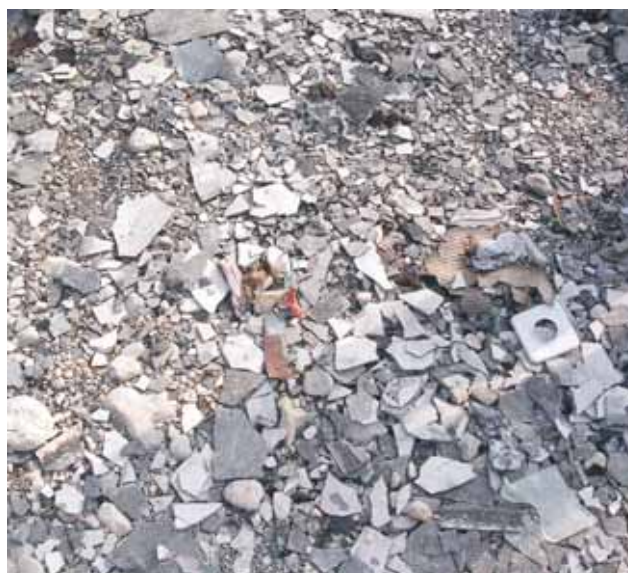
Sample number: 1/asb/001
Date sampled: 13/12/05
Analysis result: Chrysotile
(white asbestos)
Location: 31 18 46-96 N
34 13 52-07 E

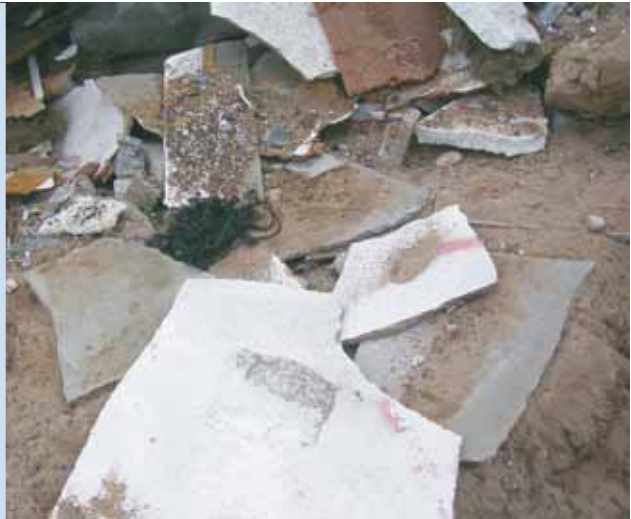
Sample number: 2/asb/002
Date sampled: 13/12/05
Analysis result: Chrysotile
(white asbestos)
Location: 31 19 18-93 N
34 14 19-59 E

Notes:
Small amounts of asbestos cement debris were noted in the area.

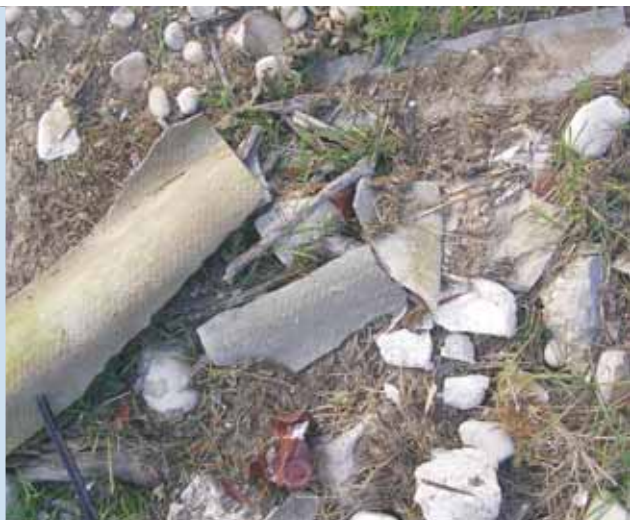
Sample number: 2/asb/003
Date sampled: 13/12/05
Analysis result: Chrysotile
(white asbestos)
Location: 31 18 59-56 N
34 14 08-61 E

Notes:
The former military area contained asbestos cement debris, possibly from the roof of demolished buildings.

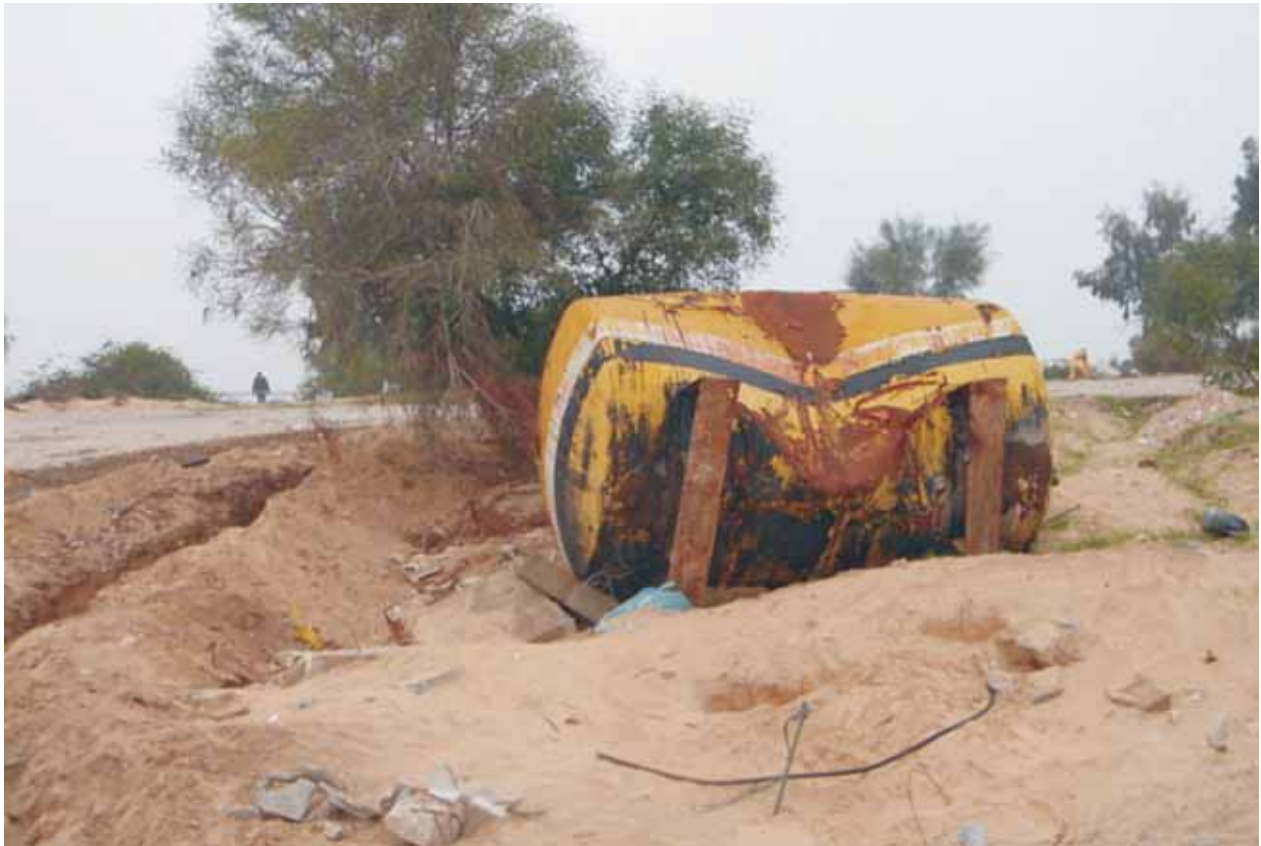
Despite the presence of this large, obsolete fuel tank, there were no significant hazardous concerns in the Slav area

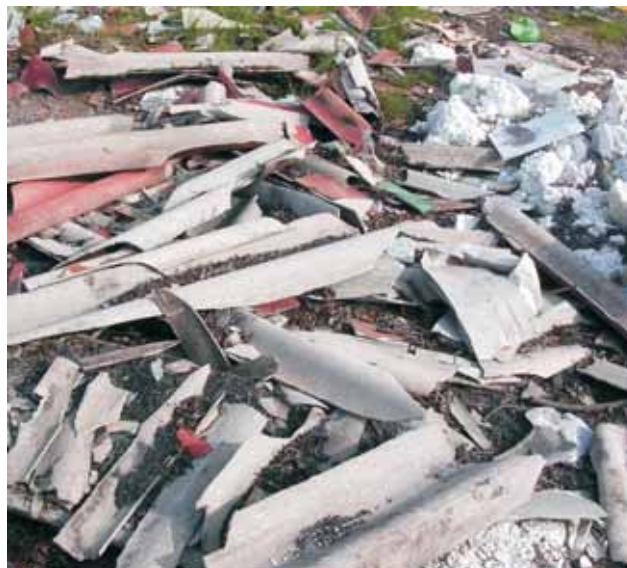
Sample number: 3/asb/001
Date sampled: 13/12/05
Analysis result: Chrysotile
 (white asbestos)
Location: 31 19 29-57 N
 34 15 02-20 E

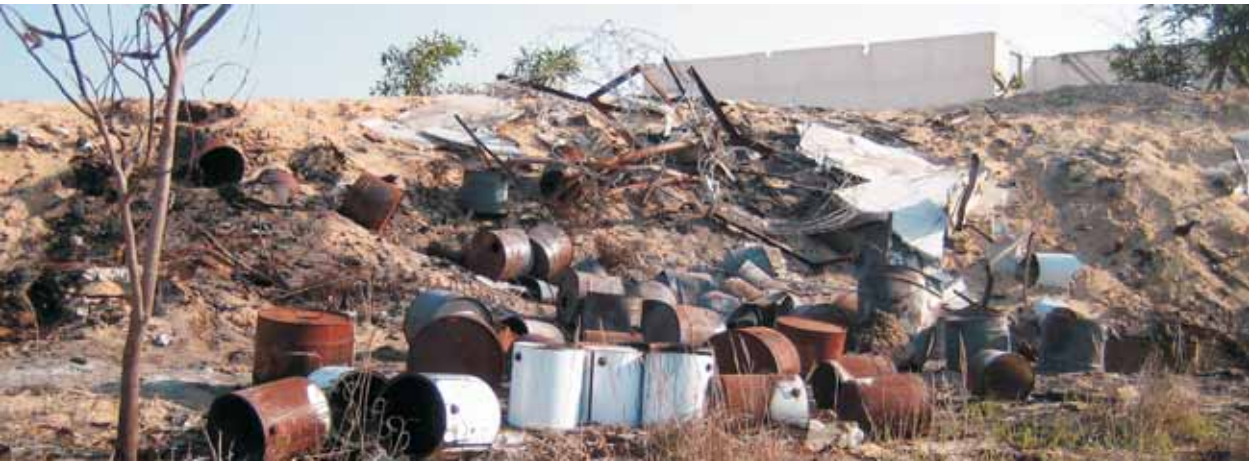
Dumped waste at Gan Or. Although unsightly, contamination was minimal

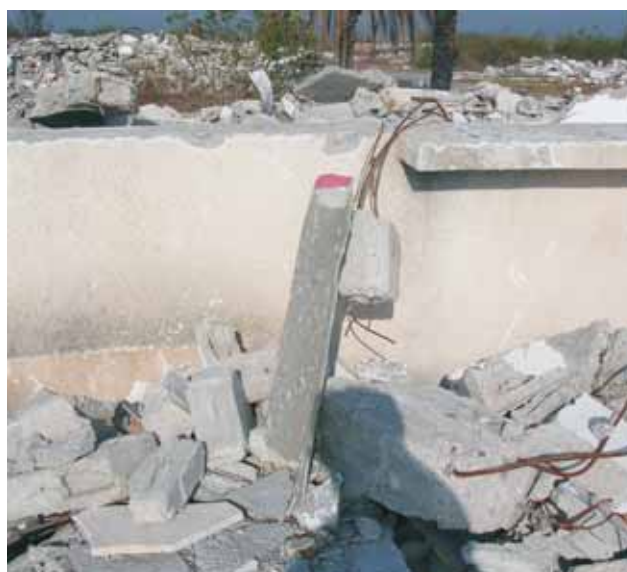
Sample number: /
Date sampled: 13/12/05
Analysis result: Assumed Chrysotile (white asbestos)
Location: 31 20 13-23 N
 34 15 32-77 E

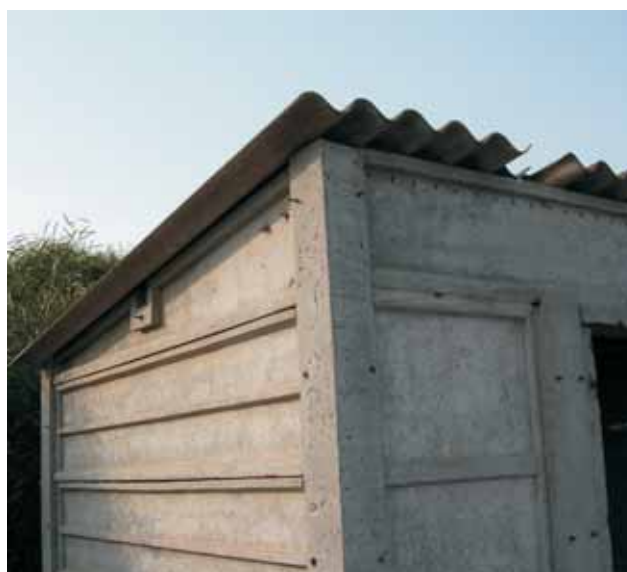
Sample number: /
Date sampled: 15/12/05
Analysis result: Assumed Chrysotile (white asbestos)
Location: 34 67 95-98 N
 62 11 60-37 E
Notes: An example of asbestos cement sheet on a small building at the rear of the green-houses.

1. Prior to the disposal and reuse of the demolition waste, asbestos should be identified and sorted out.
2. The material identified as ash (Location C), should be collected and transported to a central storage area for further treatment and disposal.

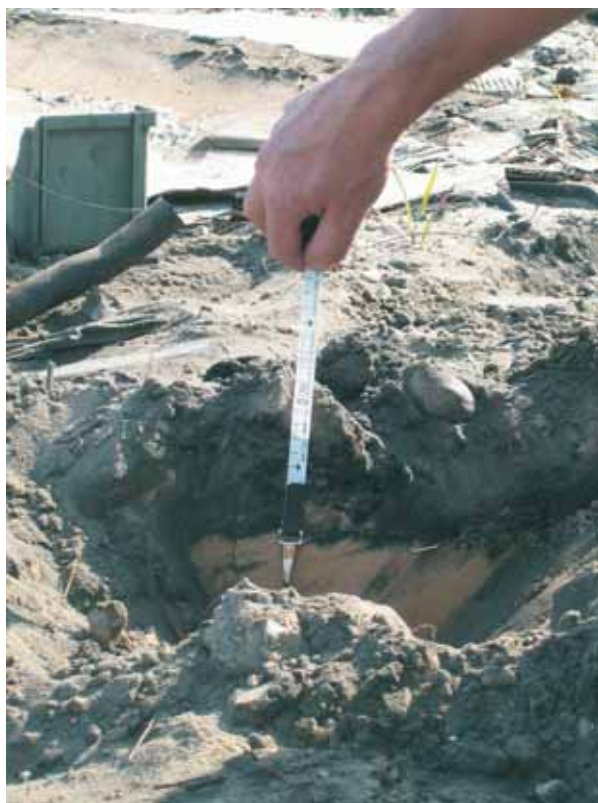
The maximum depth of the impacted "burned" zone at location A was 10 centimeters

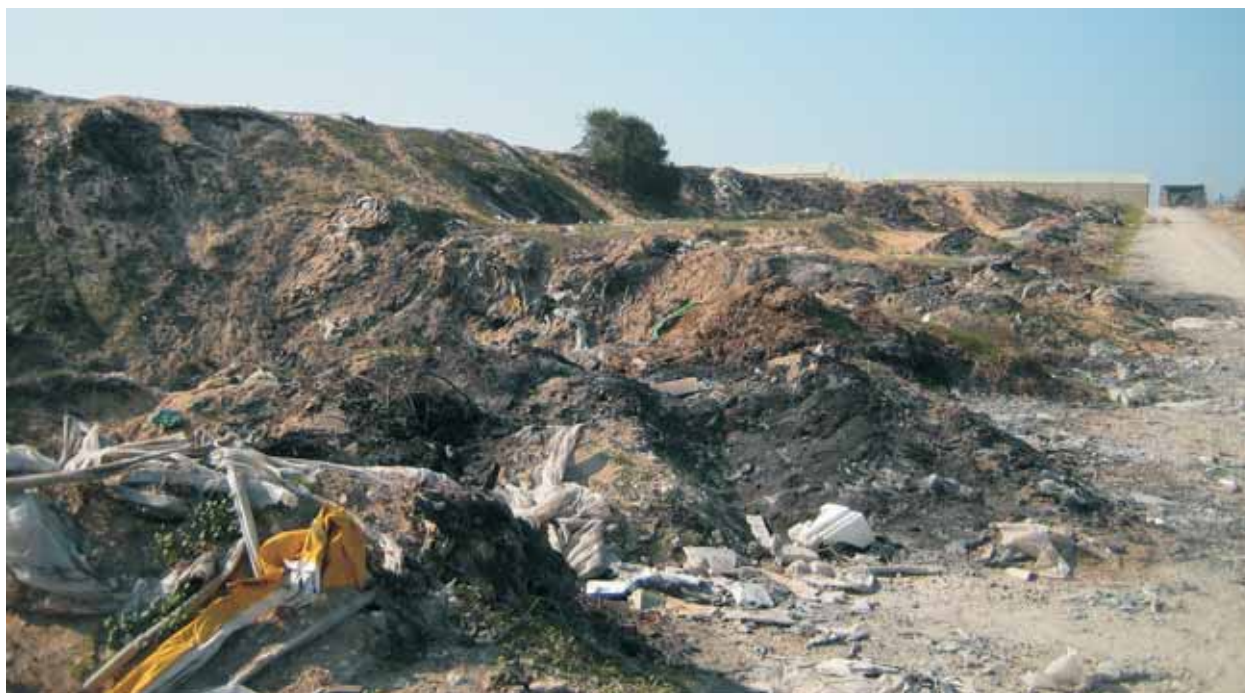
Large area of some 500 m² impacted by waste materials, at location B in Nieve Dkalim

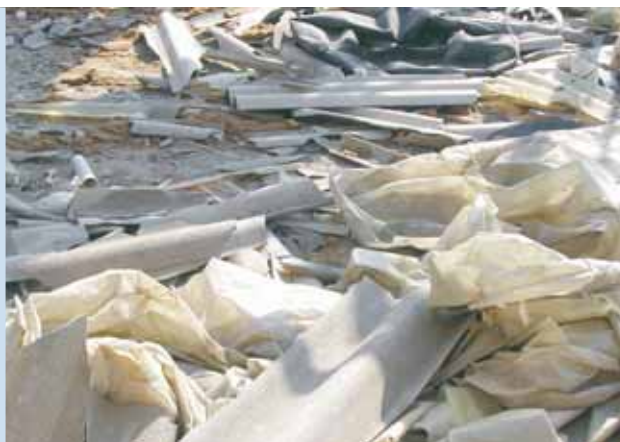
Sample number: /
Date sampled: 14/12/05
Analysis result: Assumed Chrysotile
 (white asbestos)
Location: 31 21 09-97 N
 34 16 59-98 E

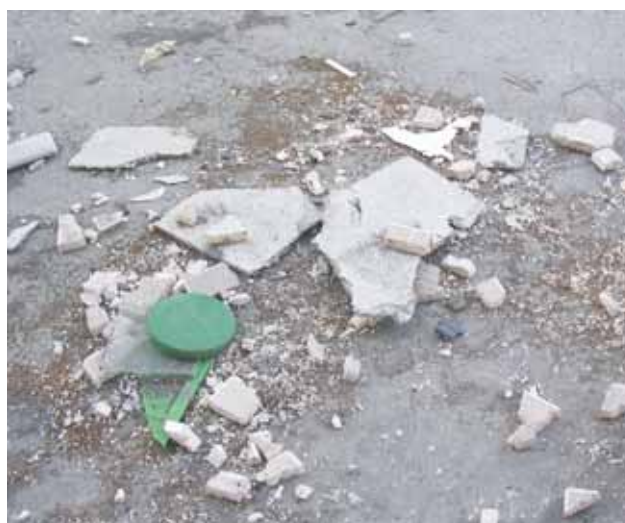
Sample number: 10/asb/002
Date sampled: 14/12/05
Analysis result: Amosite
 (brown asbestos)
Location: 31 21 10-06 N
 34 17 01-40 E

Notes:
 Asbestos insulation board was noted in one of the factory units. Great care should be taken in this area as it was not possible to identify the original source of the material.

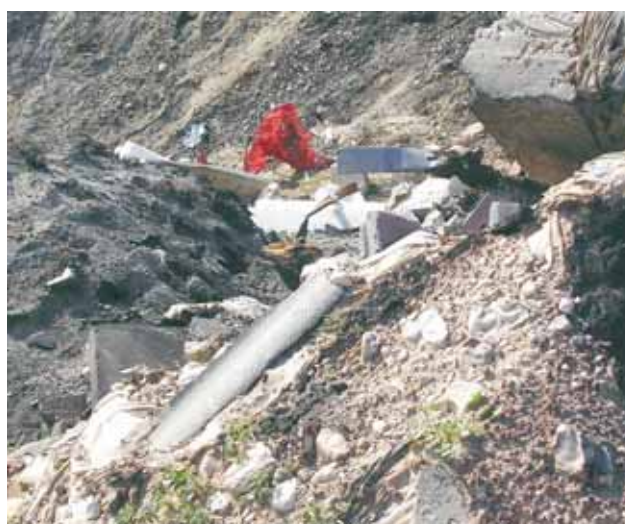
Sample number: /
Date sampled: 13412/05
Analysis result: Assumed Chrysotile
 (white asbestos)
Location: 31 21 10-15 N
 34 17 01-46 E

Notes:
 Asbestos cement debris was noted in the former waste disposal area.

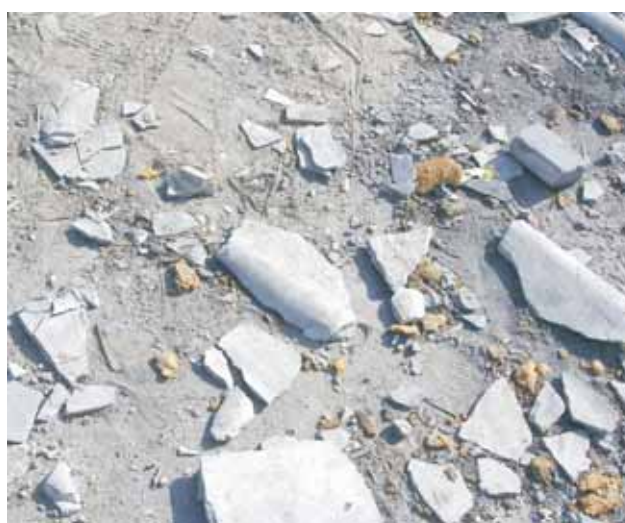
Sample number: /
Date sampled: 14/12/05
Analysis result: Assumed Chrysotile
 (white asbestos)
Location: GPS not available

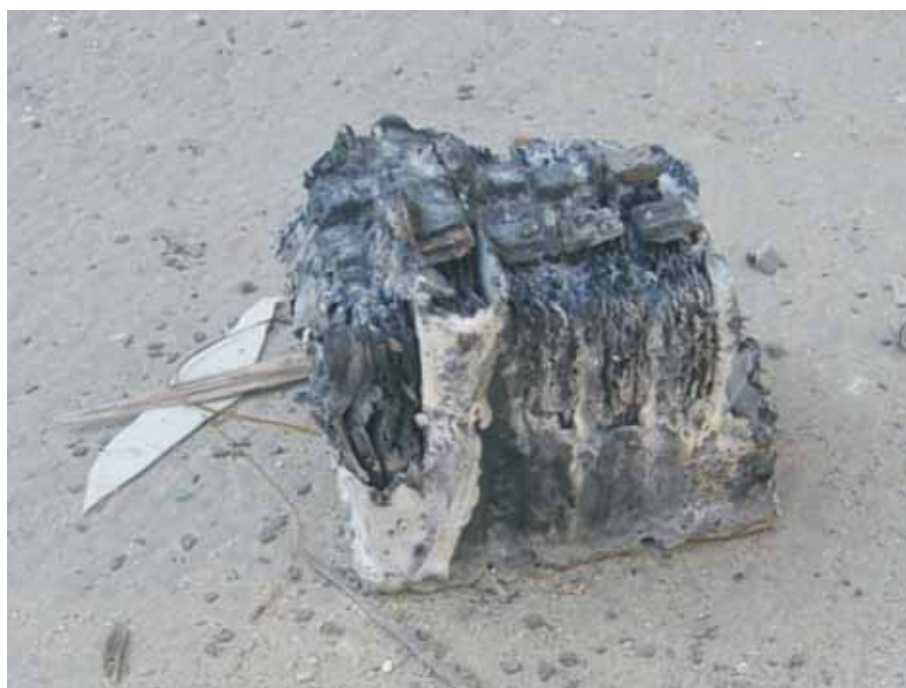
The remains of a burned lead-acid battery at Nieve Dkalim

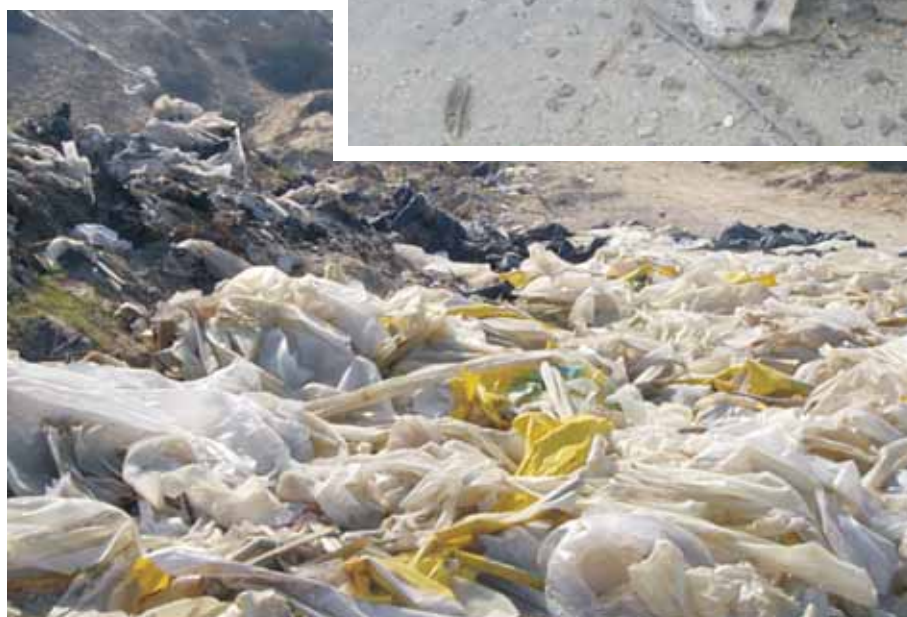
Part of Nieve Dkalim's waste disposal site showing plastic material

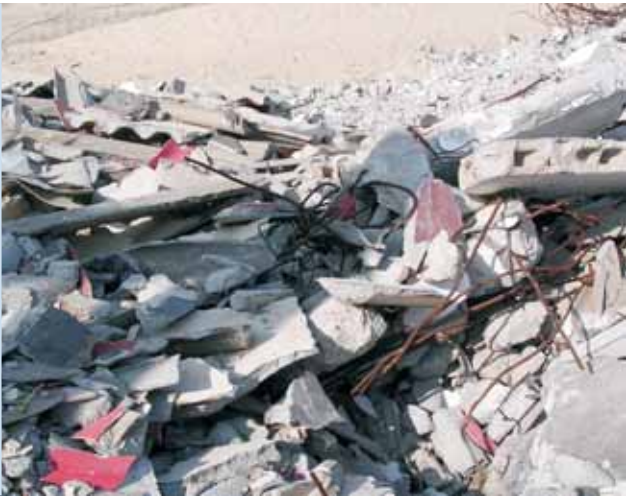
Sample number: /
Date sampled: 15/12/05
Analysis result: Assumed Chrysotile
(white asbestos)
Location: Kfar Yam beach

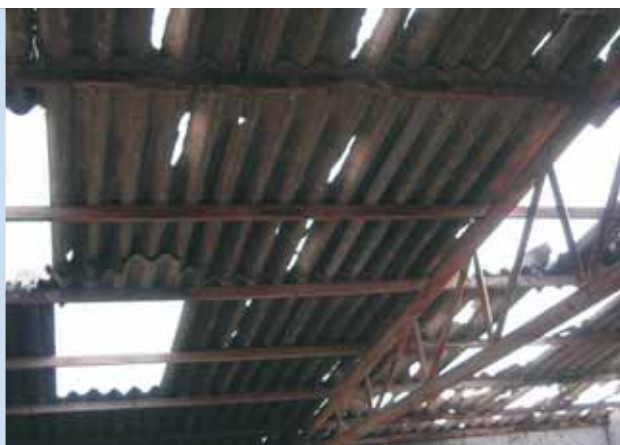
Sample number: /
Date sampled: 15/12/05
Analysis result: Assumed Chrysotile (white asbestos)
Location: GPS not available
Notes: Asbestos cement sheeting outside and to the rear of the building.

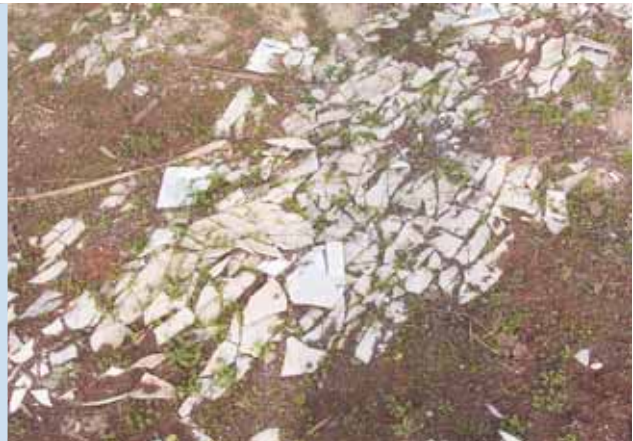
Sample number: /
Date sampled: 12/12/05
Analysis result: Assumed Chrysotile
(white asbestos)
Location: GPS not available
Notes:
A former garage that had been subject to fire damage was noted on the site. The roof appeared to have been constructed of asbestos cement.

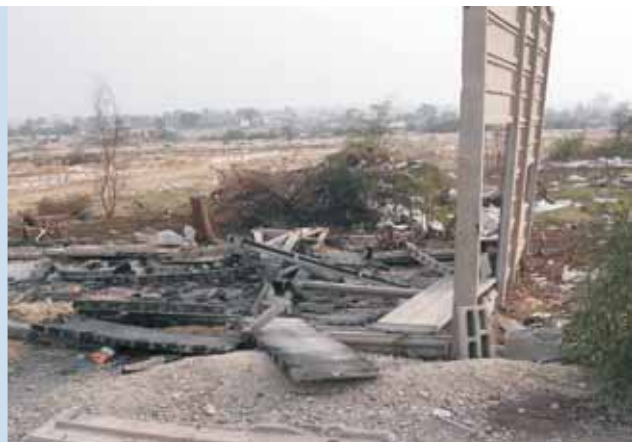
Sample number: /
Date sampled: 12/12/05
Analysis result: Assumed Chrysotile
(white asbestos)
Location: GPS not available
Notes:
The asbestos cement debris was widespread in this area. It was also possible to identify other areas of asbestos cement debris in this location.

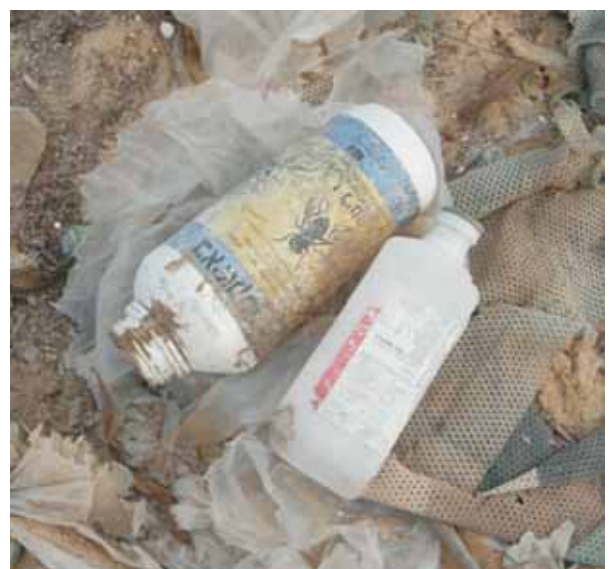
Containers, such as those shown here, were found around the Katif site

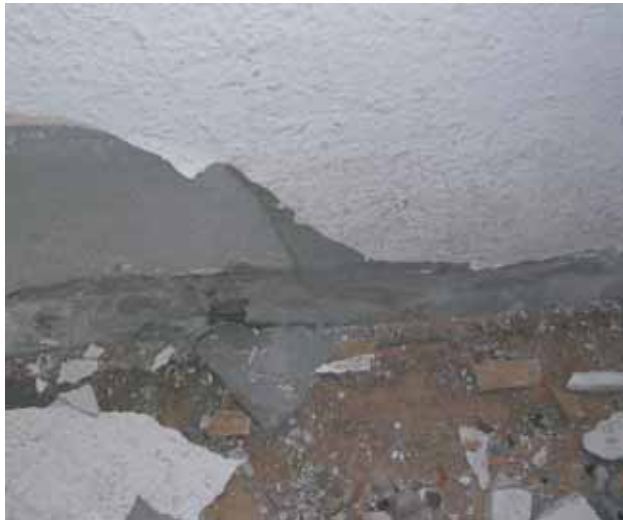
Sample number: 15/asb/002
Date sampled: 12/12/05
Analysis result: Asbestos
not detected
Location: GPS not available
Notes:
A sample of the textured coating paint from the inside of the synagogue was taken for analysis. Asbestos was not detected in the sample.

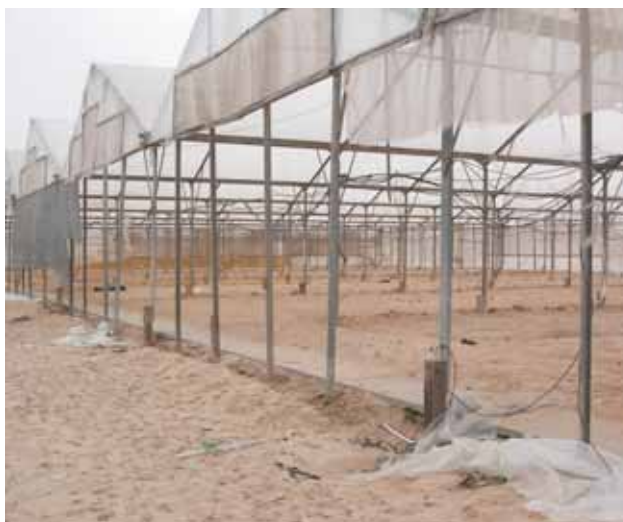
Sample number: /
Date sampled: 12/12/05
Analysis result: /
Location: GPS not available
Notes:
Asbestos cement debris was noted in the greenhouse area.

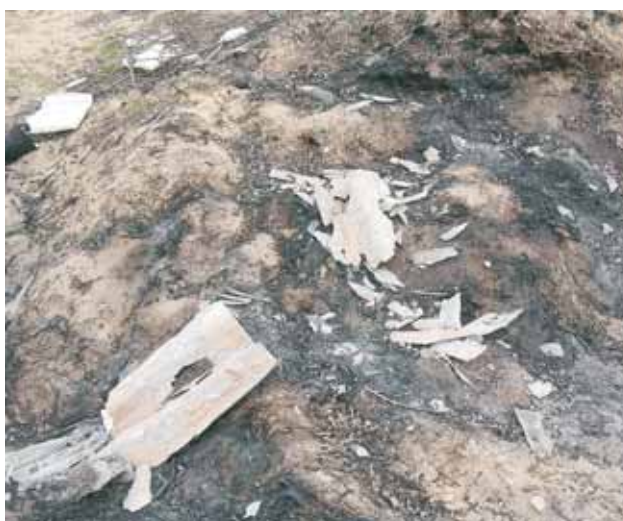
Sample number: 15/asb/003
Date sampled: 12/12/05
Analysis result: Chrysotile
(white asbestos)
Location: GPS not available
Notes:
An area of asbestos cement debris adjacent to the greenhouse area had been subject to damage by fire.

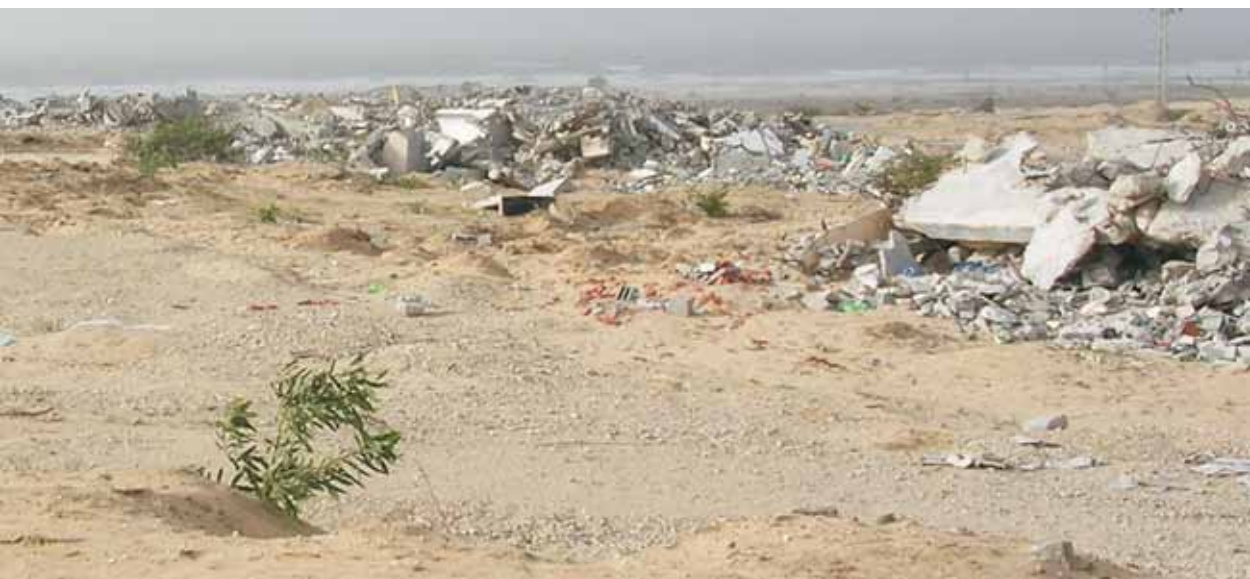
Rubble removal is the primary problem in Dugit

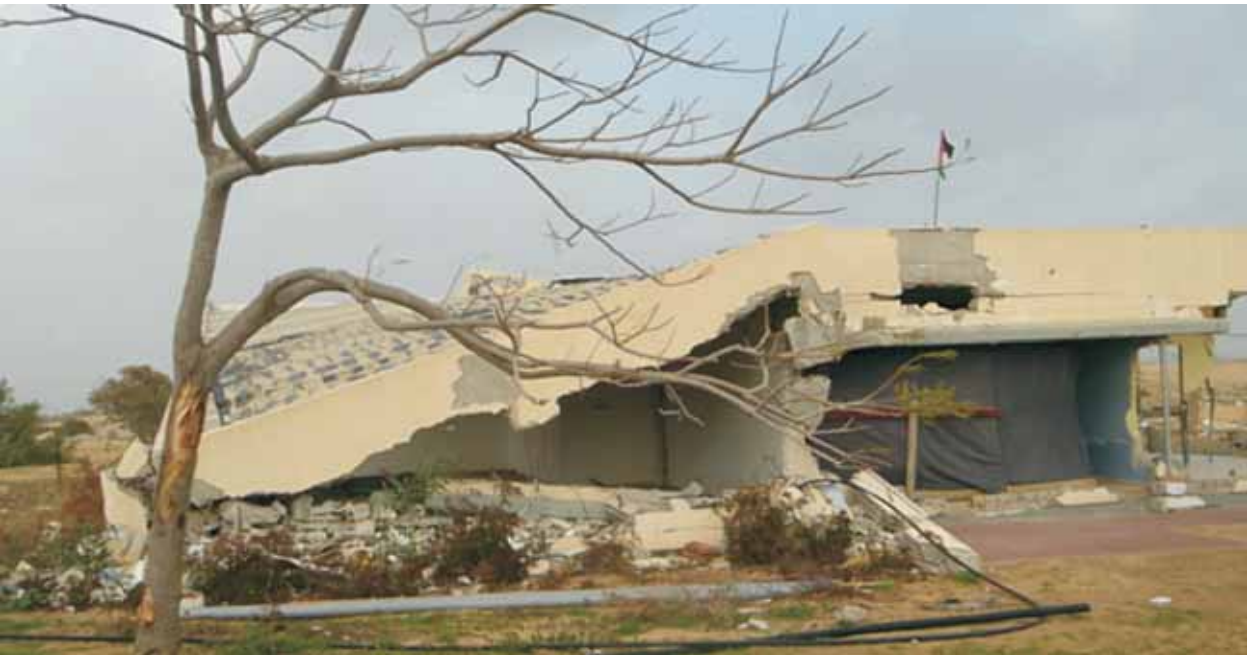
As with the other small settlements, the main issue was rubble

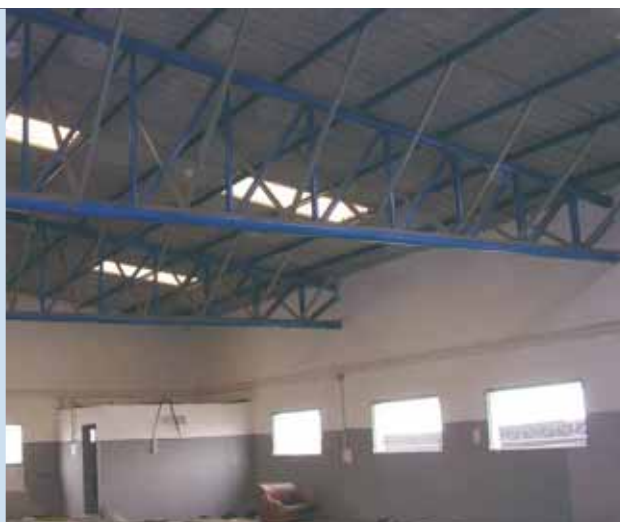
Sample number: Erez/asb/001
Date sampled: 16/12/05
Analysis result: Chrysotile (white asbestos)
Location: 31 33 23-37 N
 34 32 13-48 E
Notes:
 In a number of locations the asbestos sheets had been dropped on to the floor of the buildings.

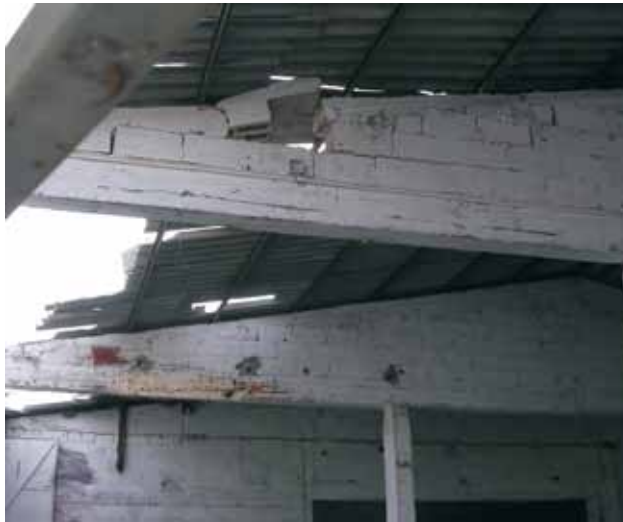
Sample number: /
Date sampled: 16/12/05
Analysis result: Assumed Chrysotile (white asbestos)
Location: GPS not available
Notes:
Damaged asbestos cement sheets where still fixed to some of the buildings.

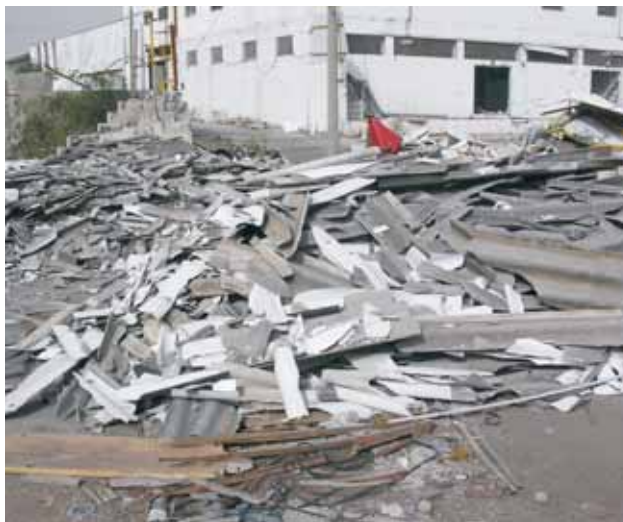
Sample number: /
Date sampled: 16/12/05
Analysis result: Assumed Chrysotile (white asbestos)
Location: GPS not available
Notes:
Large stock pipes of asbestos cement where noted in one location.

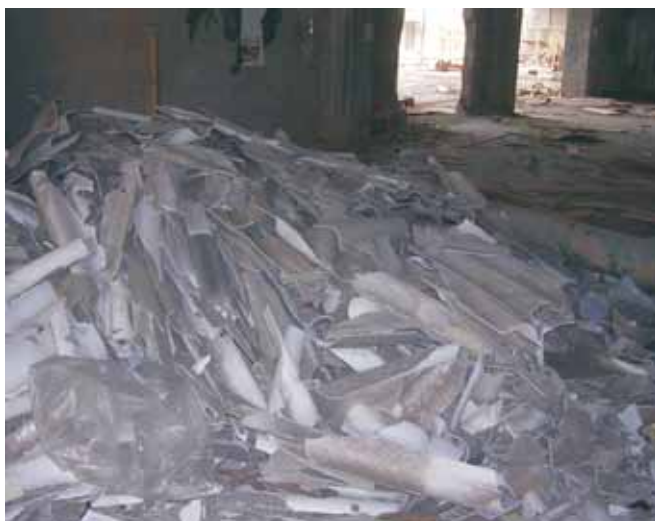
Sample number: /
Date sampled: 16/12/05
Analysis result: Assumed Chrysotile (white asbestos)
Location: GPS not available
Notes:
A significant amount of asbestos cement had been stored in this industrial unit.

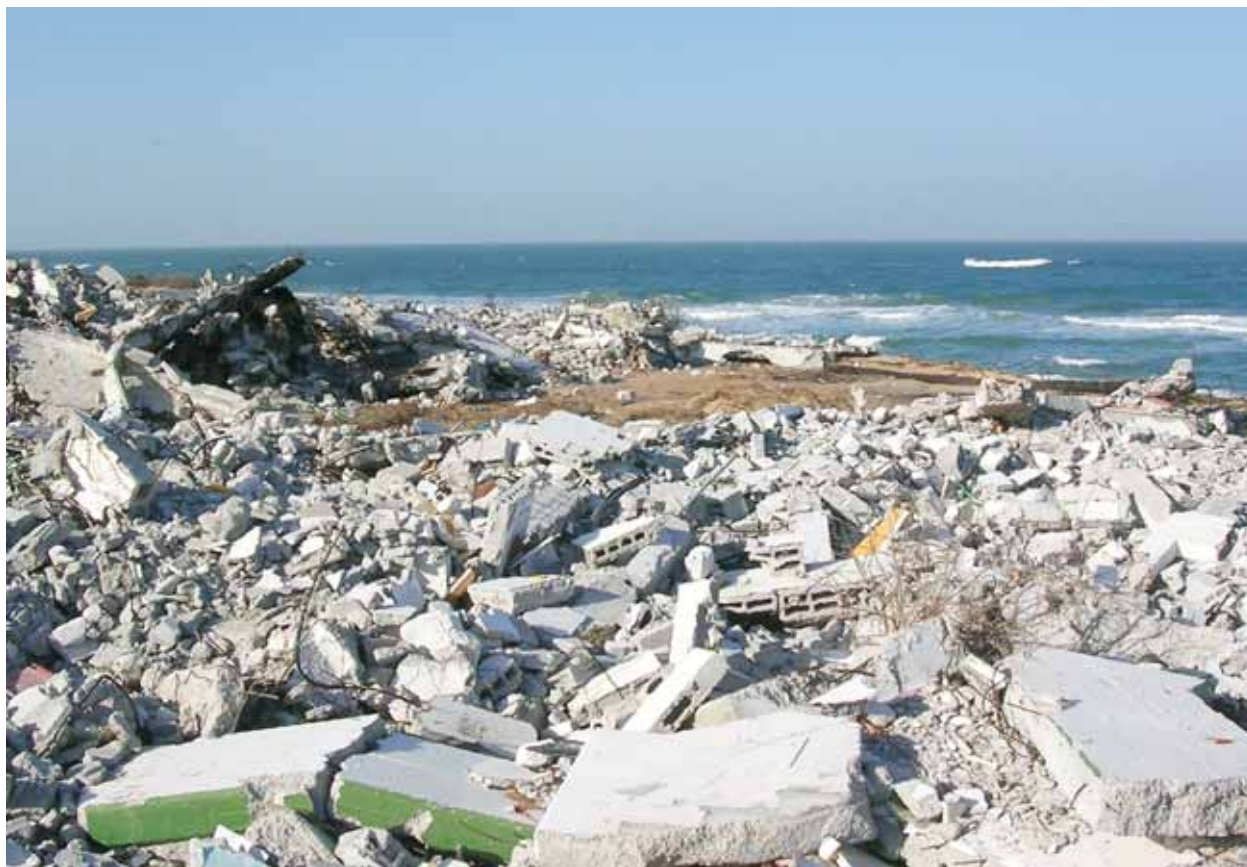
Rubble at Gaza Beaches site
